Current Status of Fukushima Dai-ichi NPS - Appendix

September 17, 2012
Tokyo Electric Power Company

Side Event by Government of Japan
at 56th IAEA General Conference, Sep 17, 2012

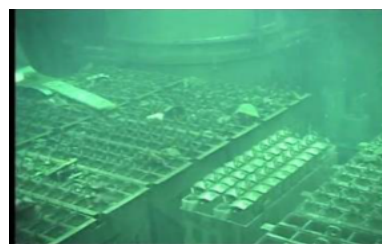
Unit 4 Spent fuel pool conditions

- Despite the Reactor Building explosion of Units 1, 2, and 4, the spent fuel pools were filled with water and cooled using the concrete pump car and Fuel Pool Cooling system
- Currently, the water level and water temperature of the various pools are stable at around 30-50 degrees
- The explosion at Unit 4 happened when all fuel was being stored in the spent fuel pool, but based on helicopter verification (March 16, 2011), nuclide analysis of pool water, and the fact that pool water filling and cooling had been accomplished, there is thought to be no damage to the pool itself

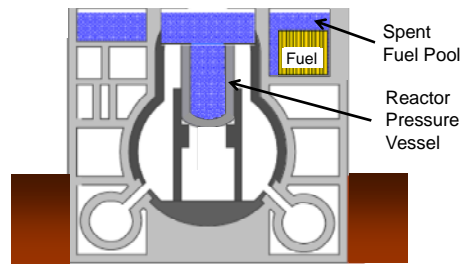
Image of the Unit 4 R/B

- The top of the Unit 4 R/B was damaged by the hydrogen explosion
BUT we confirmed that
 - the building has not tilted
 - the building, including the Spent Fuel Pool, will not collapse even if an earthquake equivalent (JMA Seismic Intensity Scale 6+) to the Tohoku-Pacific Ocean Earthquake occurs in the area.

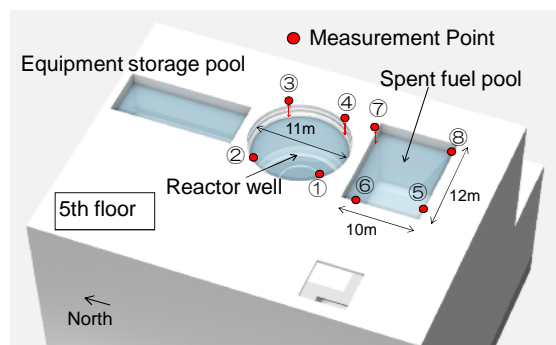
Measurement Point (on the 5th floor)

- We measured the distance between the water surface of the Spent Fuel Pool and the floor surface of the Reactor Building, and confirmed that the building has not tilted

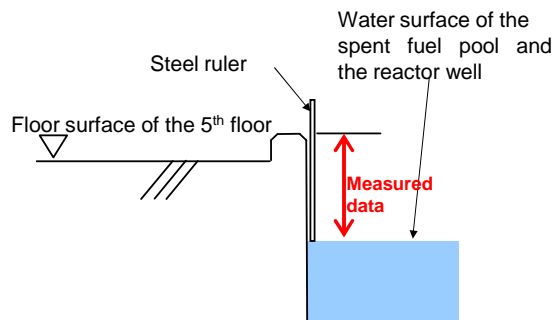
Measurement Method

- We conducted the measurements four times on Feb.7, Apr.12, May 18 and Aug.21, 2012 and the measured data at the 4 corners were almost the same.
- Thus, we confirmed that the floor surface of the 5th floor and water surfaces of the spent fuel pool and the reactor well were leveled.

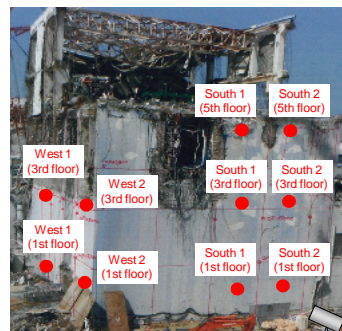
Optical equipment

Perpendicularity of the exterior wall was measured by using an optical equipment.

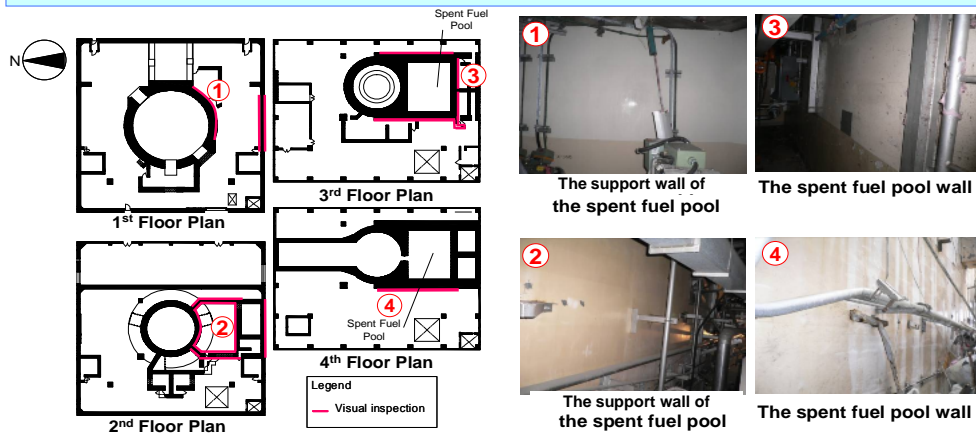
[8] Visual Inspection

We inspected the defects such as cracks on the concrete floor and walls of the spent fuel pool (building frame) .

As a result of visual inspection, cracks of which the width exceed 1mm or which have the possibility of rebar corrosion were not confirmed.

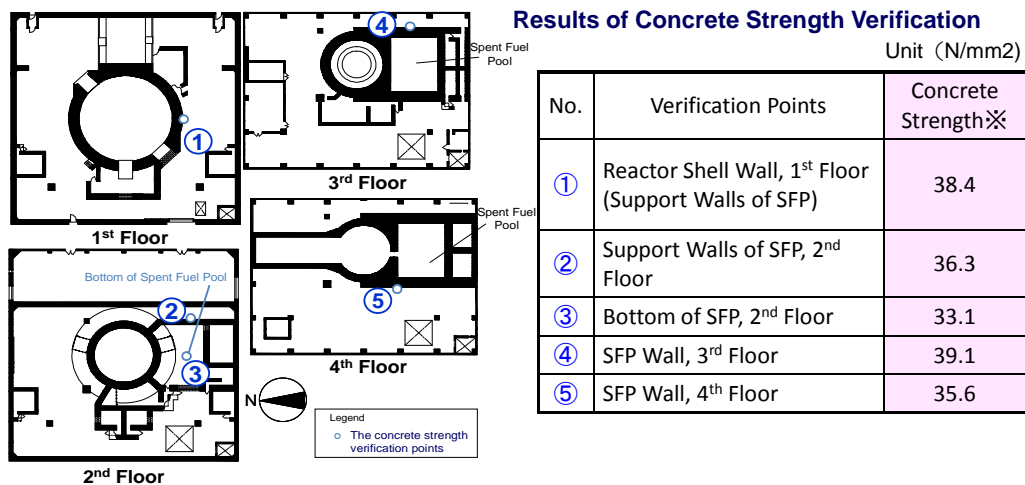
[8] Concrete Strength Verification

The concrete strength of the spent fuel pool was measured by non-destructive inspection techniques (Schmidt Hammer*) to confirm that the strength fulfills the design standard (22.1N/mm²).

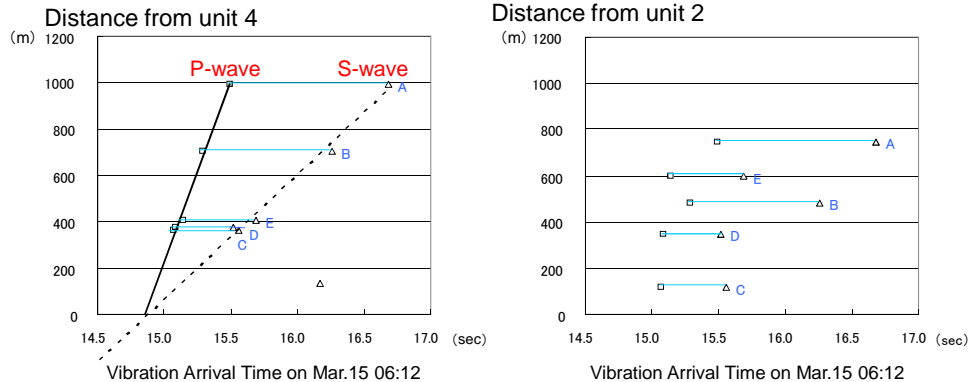
[9] Large Explosive Sound on Mar.15 , 2011

An explosion was believed to occur at unit 2, because large explosive sound seemed to accompany drop on S/C pressure at unit 2 on Mar.15, 2011

Explosive sound is confirmed to come from unit 4
