# **The 3/11 Fukushima Nuclear Accident: What Happened and Lessons learned (so far)**

**“The Nuclear Renaissance and the Risks of Nuclear  
Proliferation in Asia”**

**Tatsujiro Suzuki**

**Vice Chairman, Japan Atomic Energy Commission**

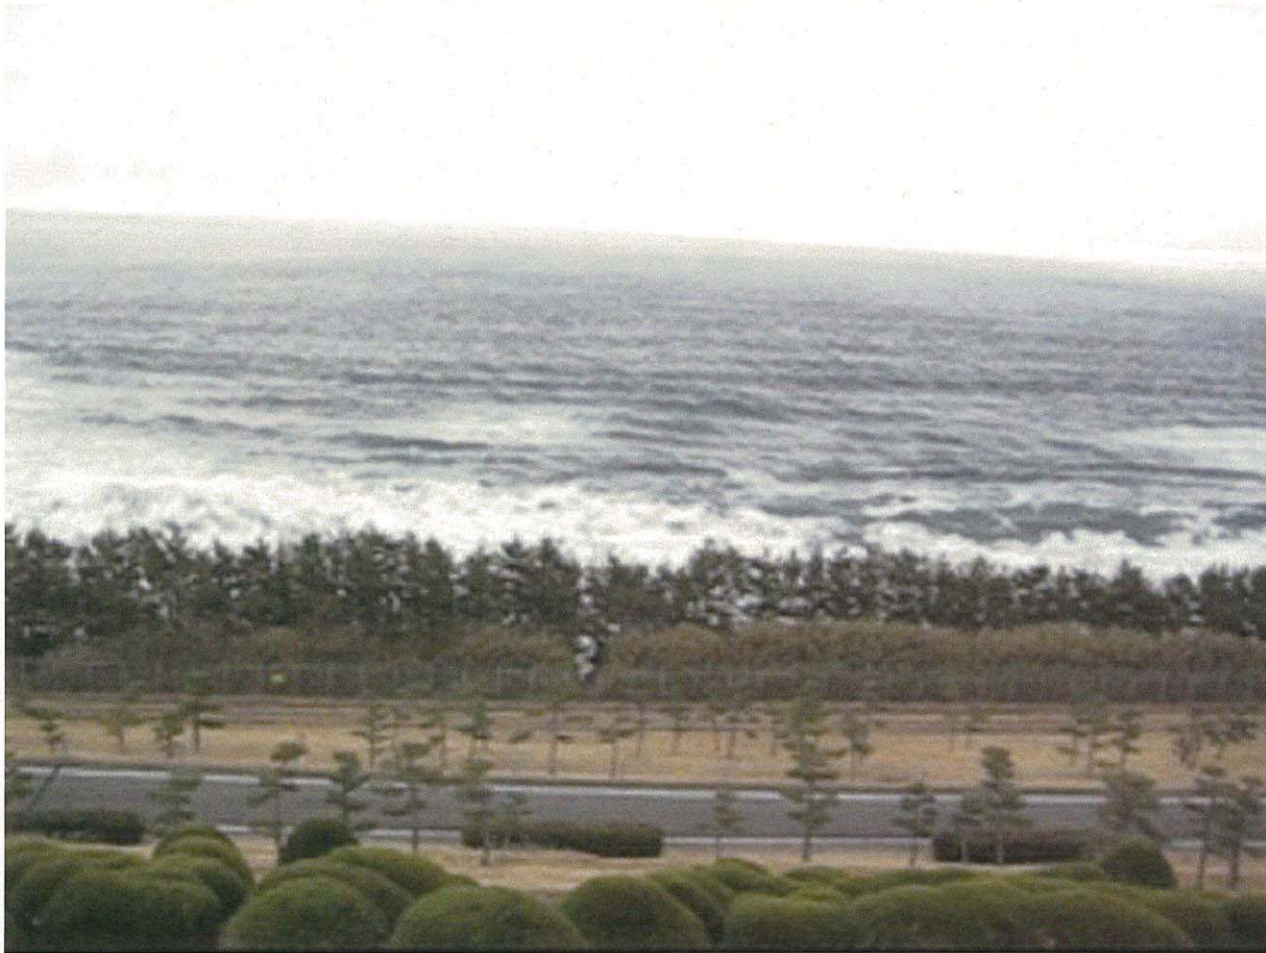
# Tsunami at Fukushima

- Occurred 14:46 March 11, 2011
- Magnitude: 9.0 Mw
- Epicenter location: 38° 6"N and 142° 51"E, and 24km in depth
- It is said that the height of tsunami attacked Fukushima NPP was more than 14m

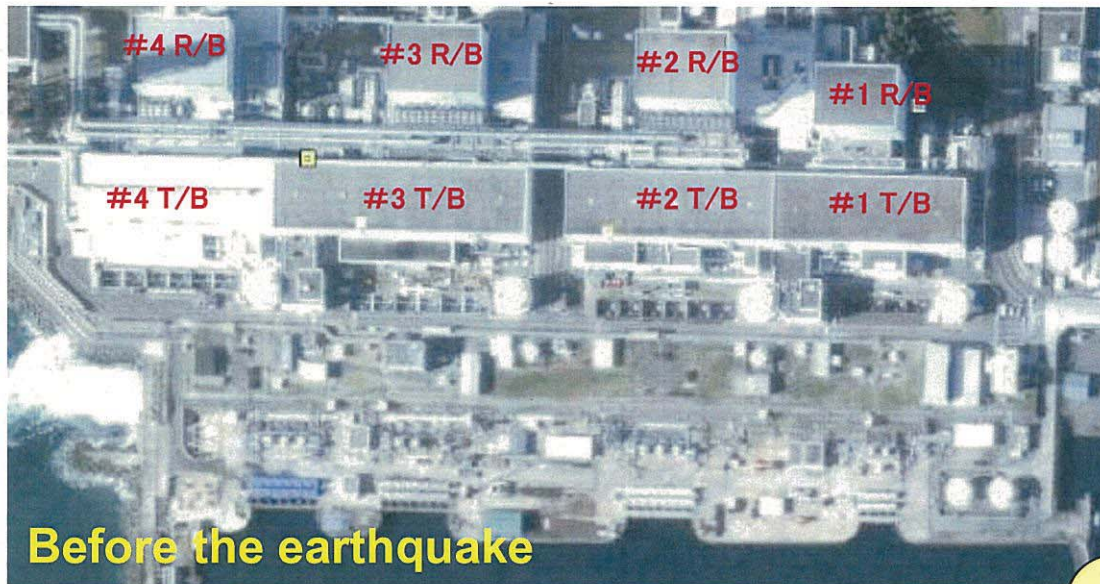
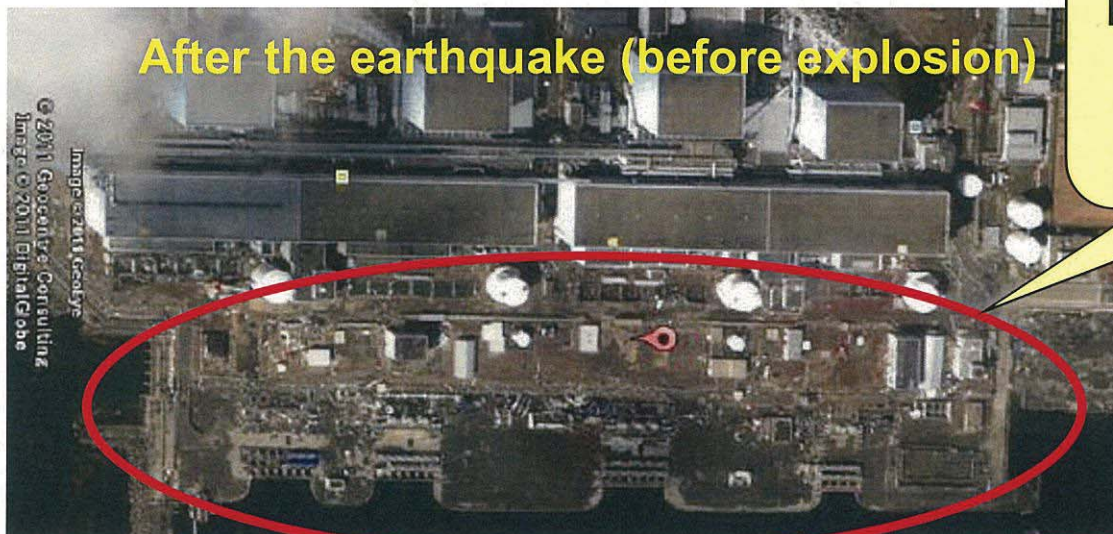
## Satellite view of Fukushima Dai-ichi NPP

Many structures facing the bay are destroyed

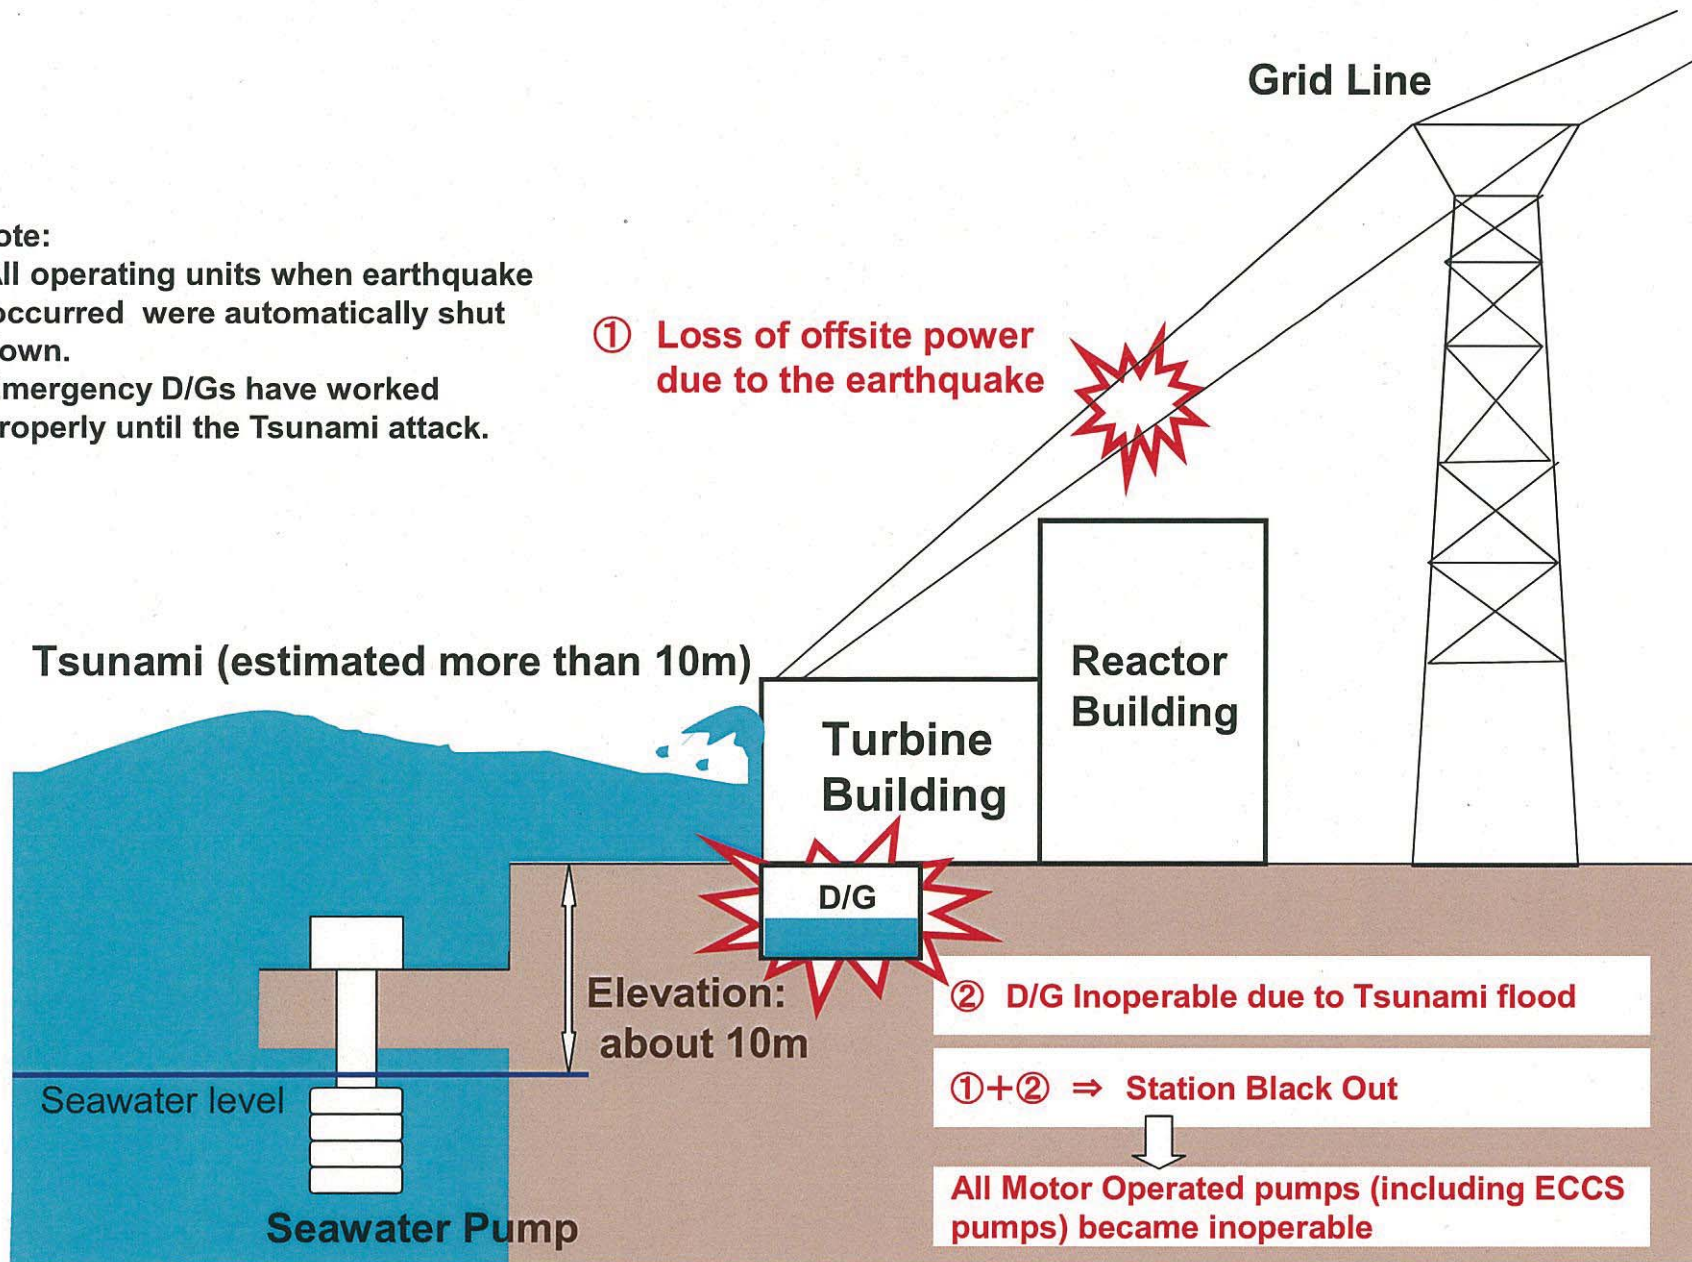
# Loss of all power sources due to the Earthquake and Tsunami

- All operating units when earthquake occurred were automatically shut down.
- Emergency D/Gs have worked properly until the Tsunami attack.

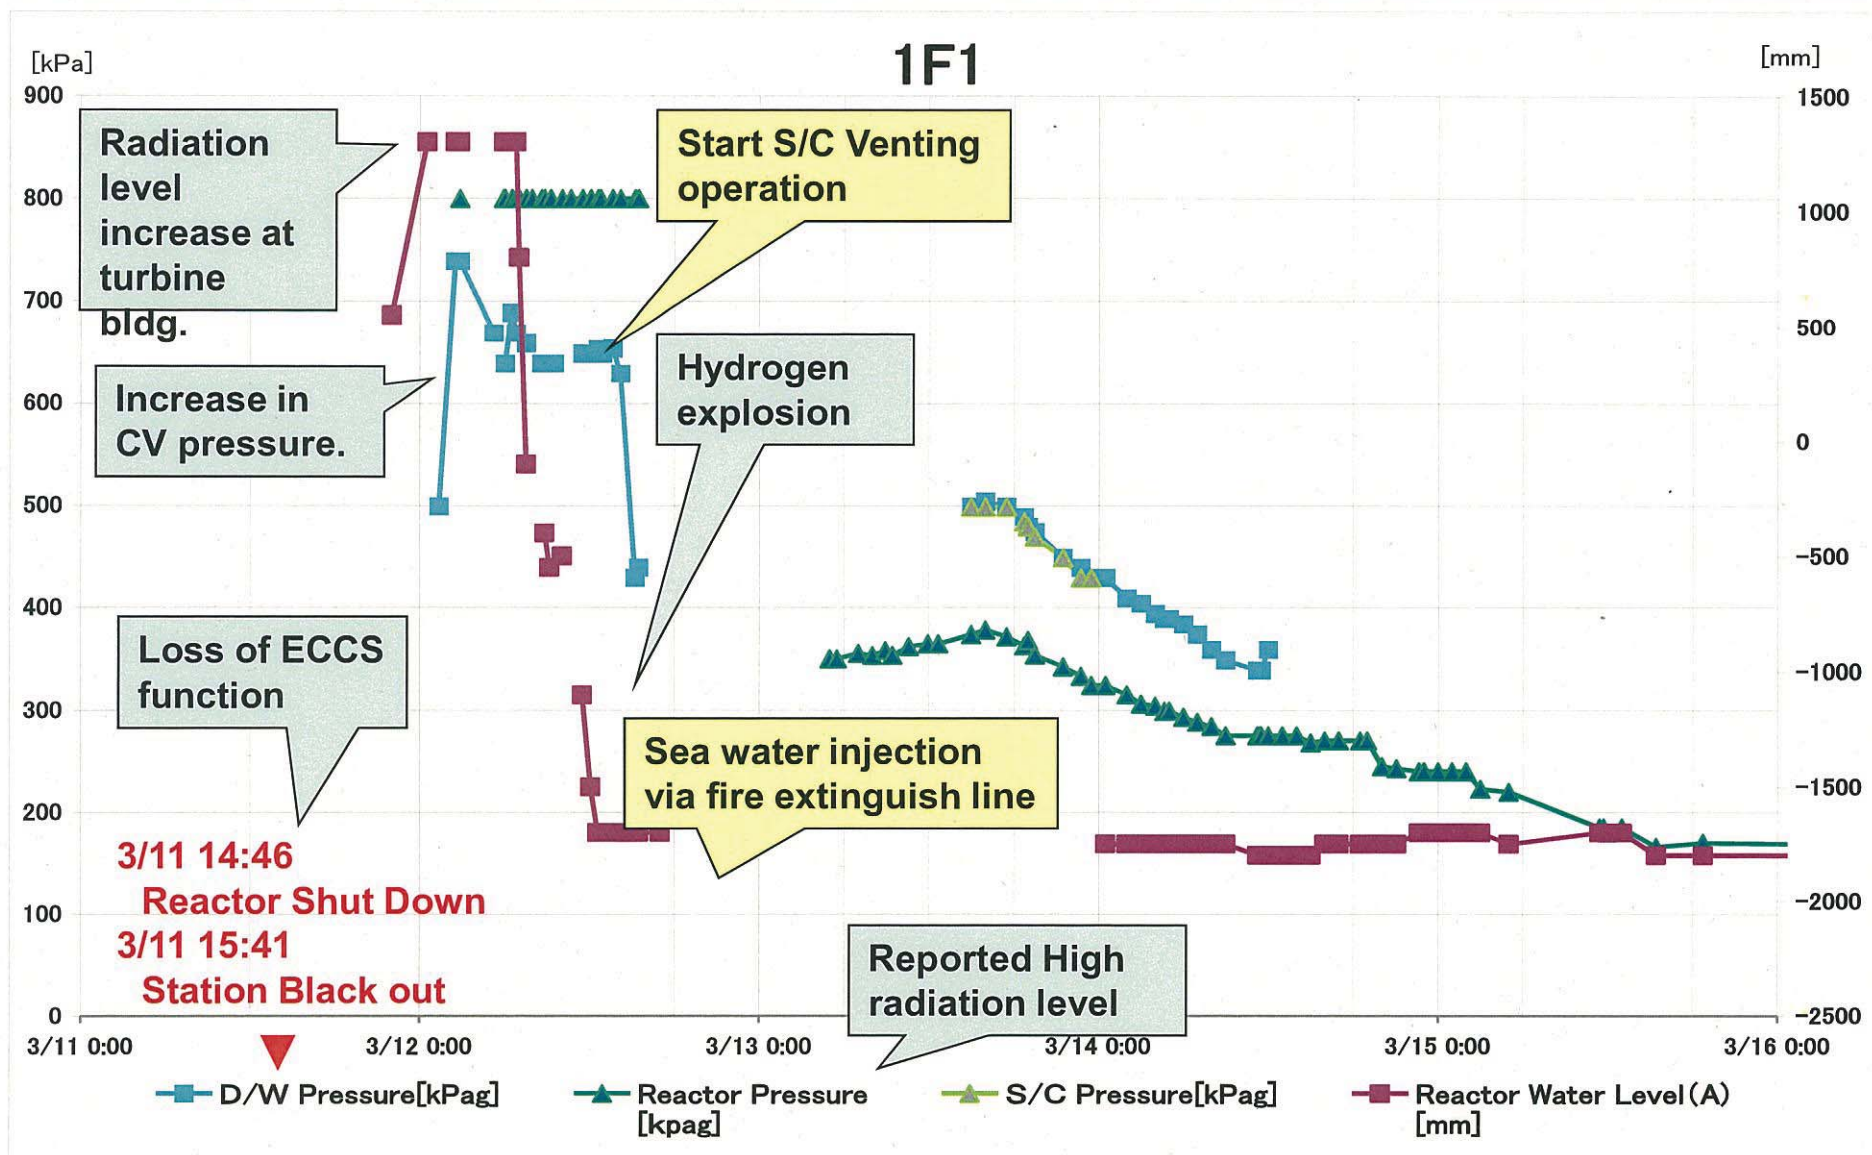
# Trend data (pressure and water level) of Unit 1 until March 15

- 11<sup>th</sup> ● Under operation, Automatic shutdown by the earthquake (14:46)
  - Loss of A/C power (15:42)
  - Loss of water injection function
- 12<sup>th</sup> ● Unusual increase of PCV pressure
  - Started to vent (10:17)
  - Sound of explosion (15:36)
  - Started of injection of seawater and borated water to the core
- 22<sup>nd</sup> ● Rise of reactor temperature (383°C) → Drop (26th 05:00 144.3°C)
- 23<sup>rd</sup> ● Water supply line in addition to the Fire Extinguish line. Switched to water supply line only.(Flow rate: 7m<sup>3</sup>/h)
- 24<sup>th</sup> ● Lighting in the Central Control Room was recovered.
- 25<sup>th</sup> ● Started fresh water injection
- 29<sup>th</sup> ● Switched to the water injection to the core using a temporary motor operated pump.
- 31<sup>st</sup> ● White smoke was confirmed to generate continuously
  - Freshwater is being injected into the RPV

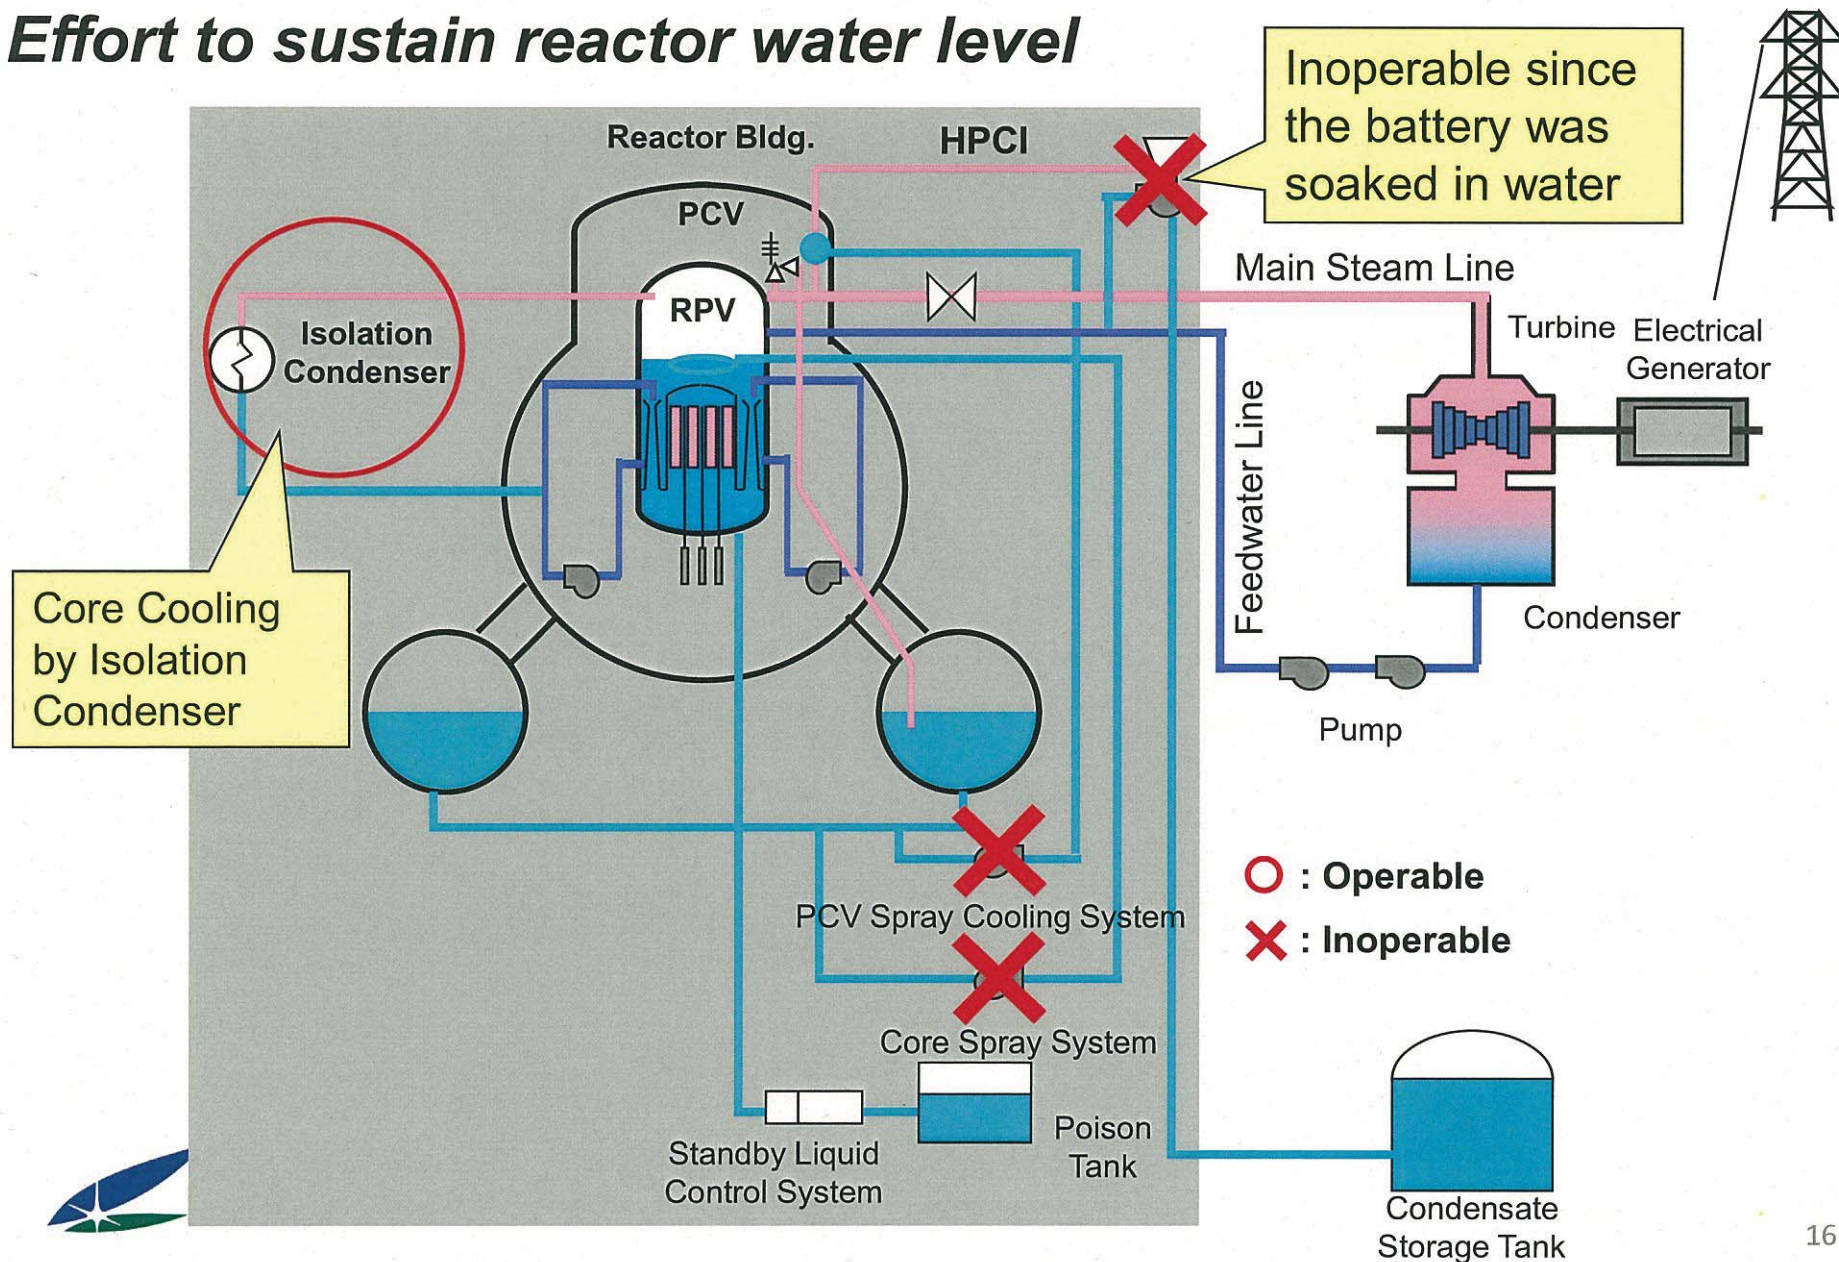
## Major event progression at Unit 1 (1/4)

### *Effort to sustain reactor water level*

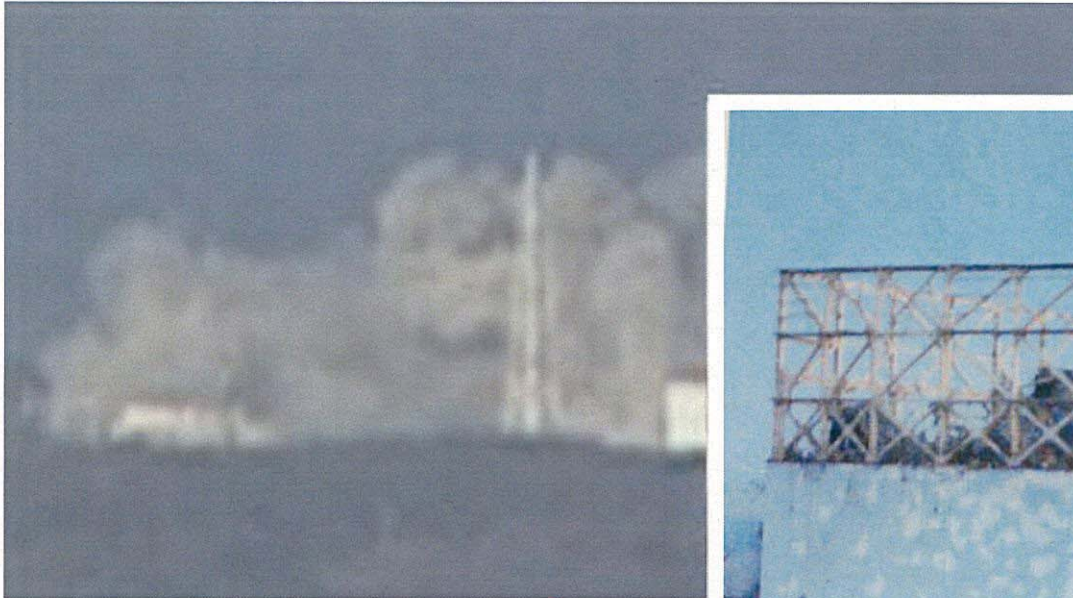
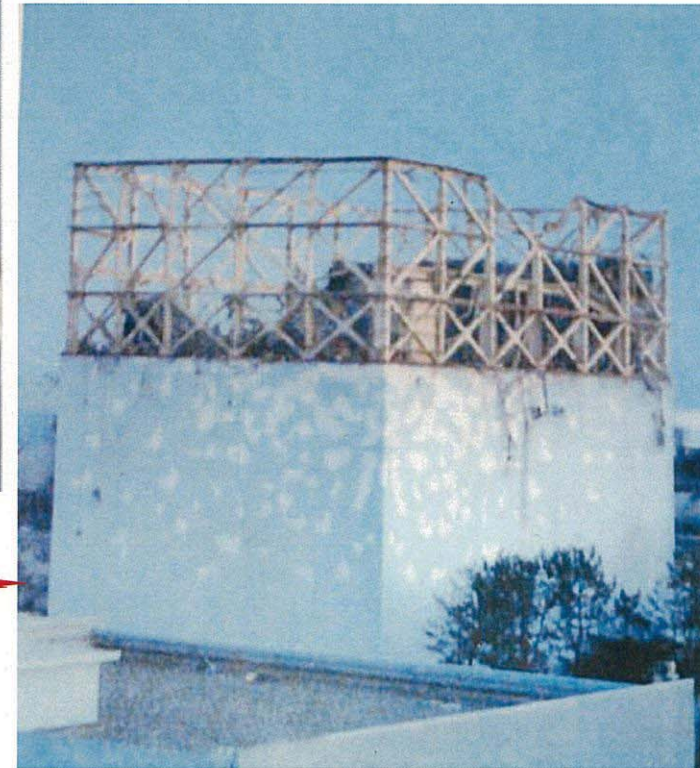
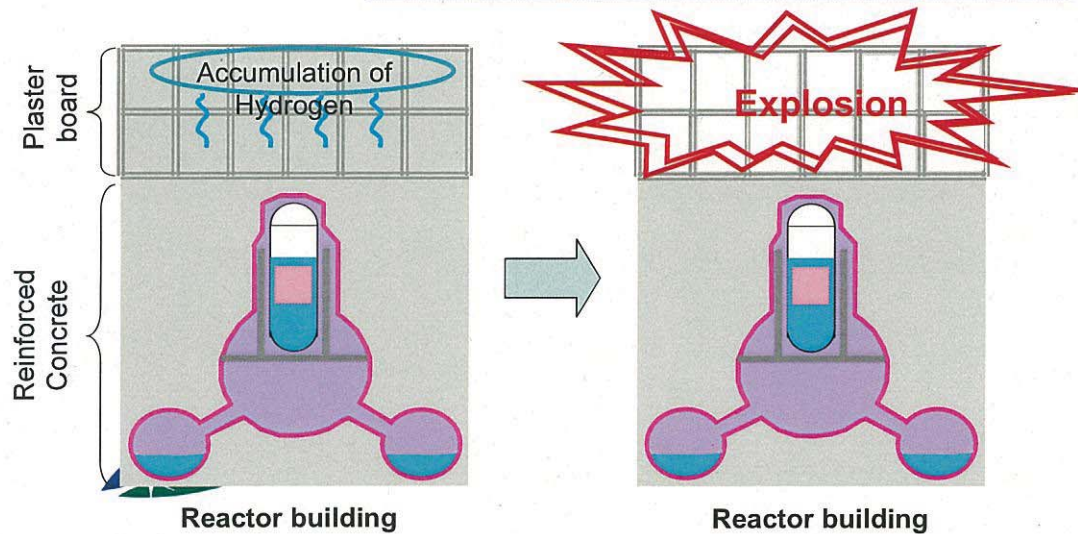
## Major event progression at Unit 1 (3/4)

### *Hydrogen explosion in the operation floor*

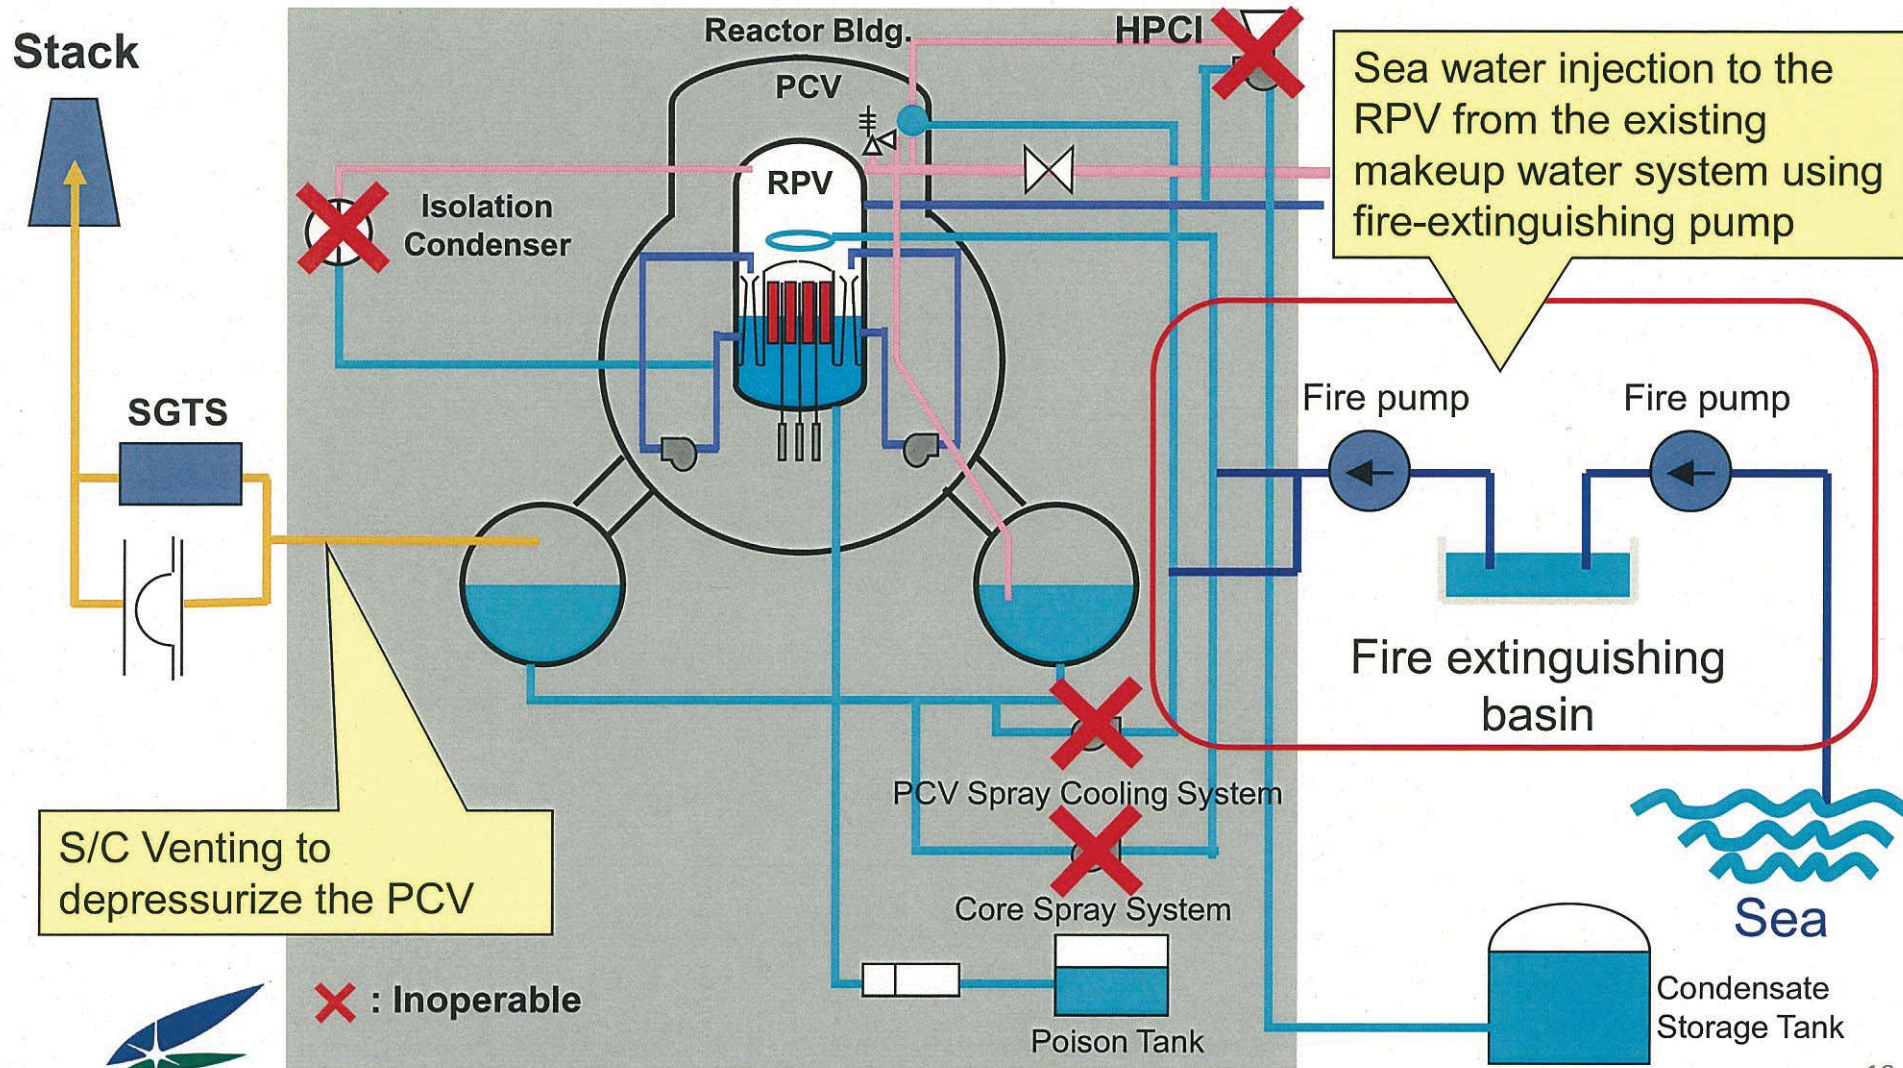
## Major event progression at Unit 1 (4/4)

- **Sea water injection using fire water pump**
- **S/C Venting to depressurize the PCV**

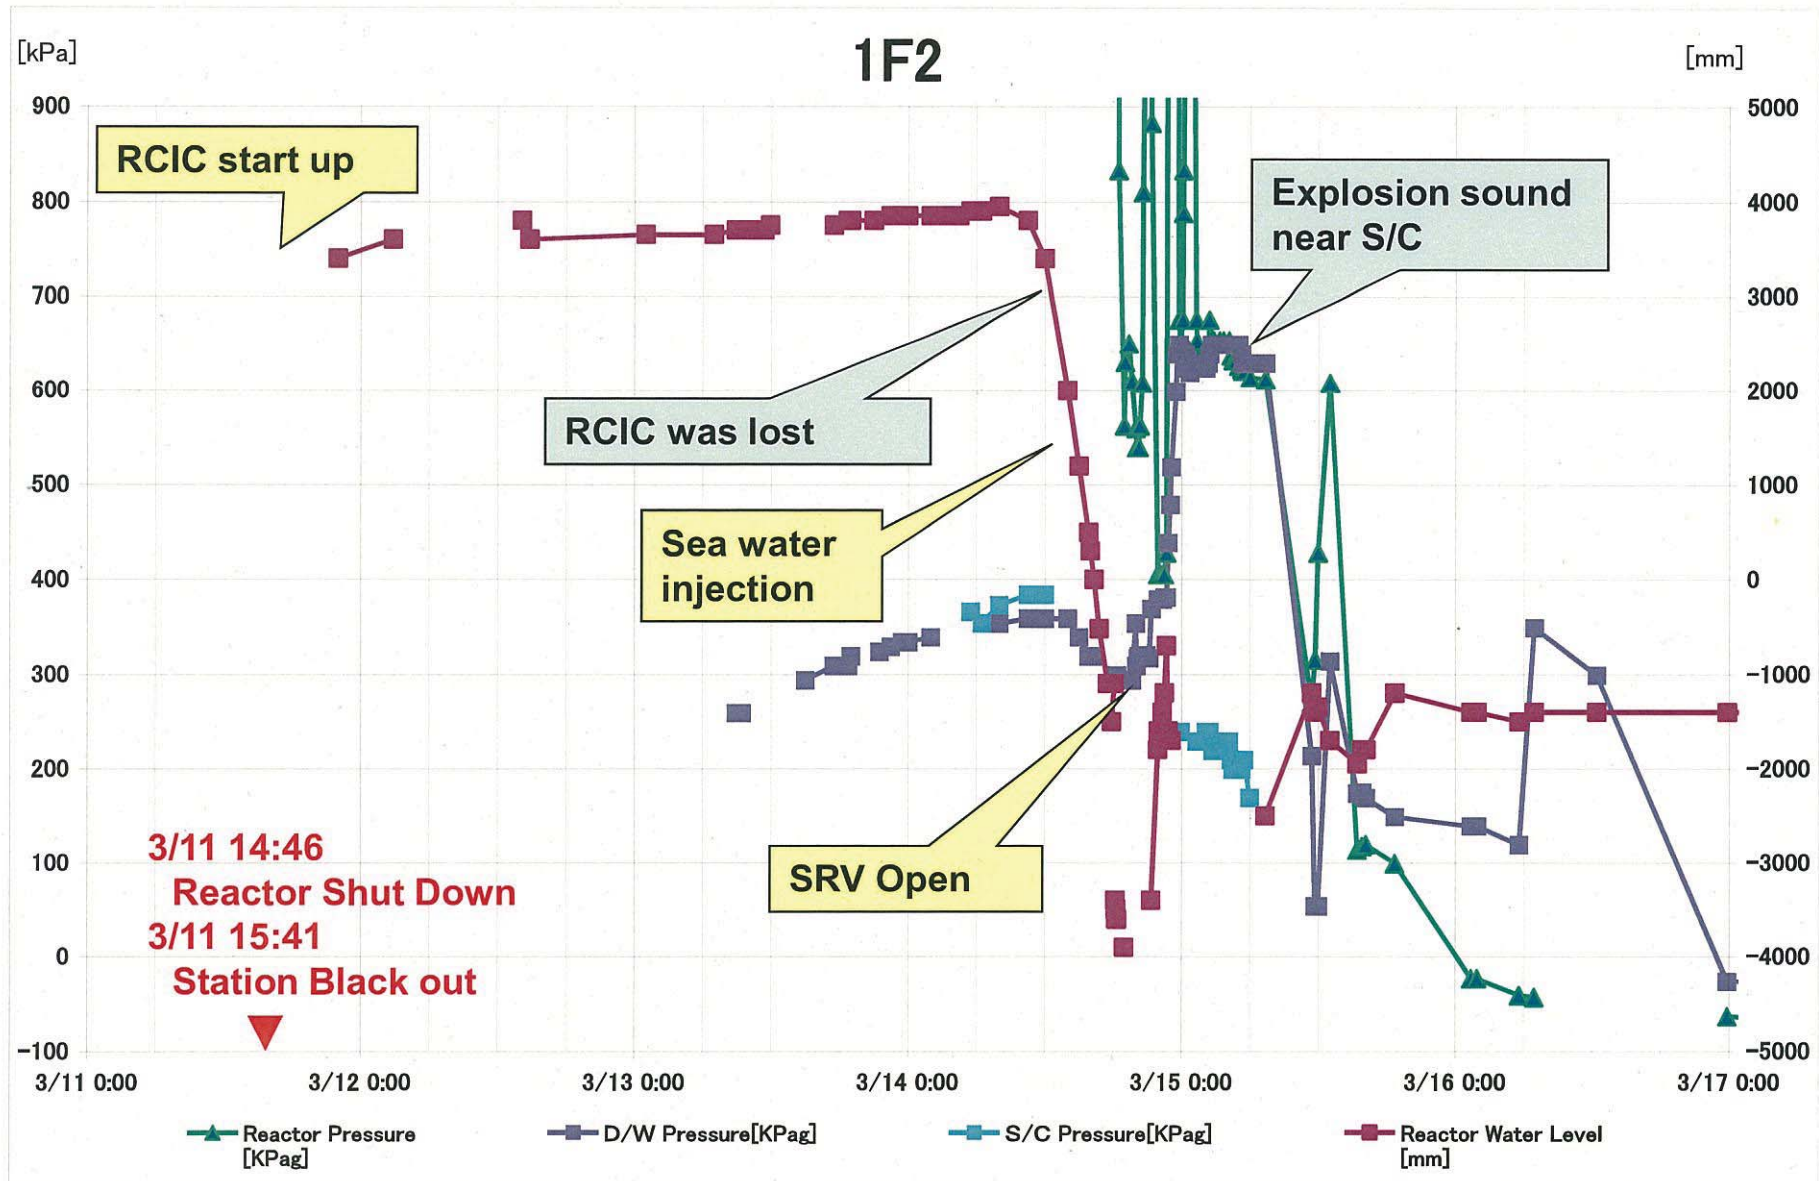
# Trend data of Unit 2 until March 17

- 11<sup>th</sup> ● Under operation, Automatic shutdown by the earthquake
  - Loss of A/C power
  - Loss of water injection function
- 14<sup>th</sup> ● Loss of water cooling function
  - Unusual increase in PCV pressure
- 15<sup>th</sup> ● **Sound of explosion(06:10)**
  - Possible damage of the suppression chamber
- 20<sup>th</sup> ● Injection of about 40 tons of seawater into SFP through fire extinguishing system.
  - Injection of seawater to the Spent Fuel Pool (SFP)
- 21<sup>st</sup> ● White smoke generated
- 22<sup>nd</sup> ● Injection of seawater to the Spent Fuel Pool (SFP)
- 25<sup>th</sup> ● Injection of seawater to SFP

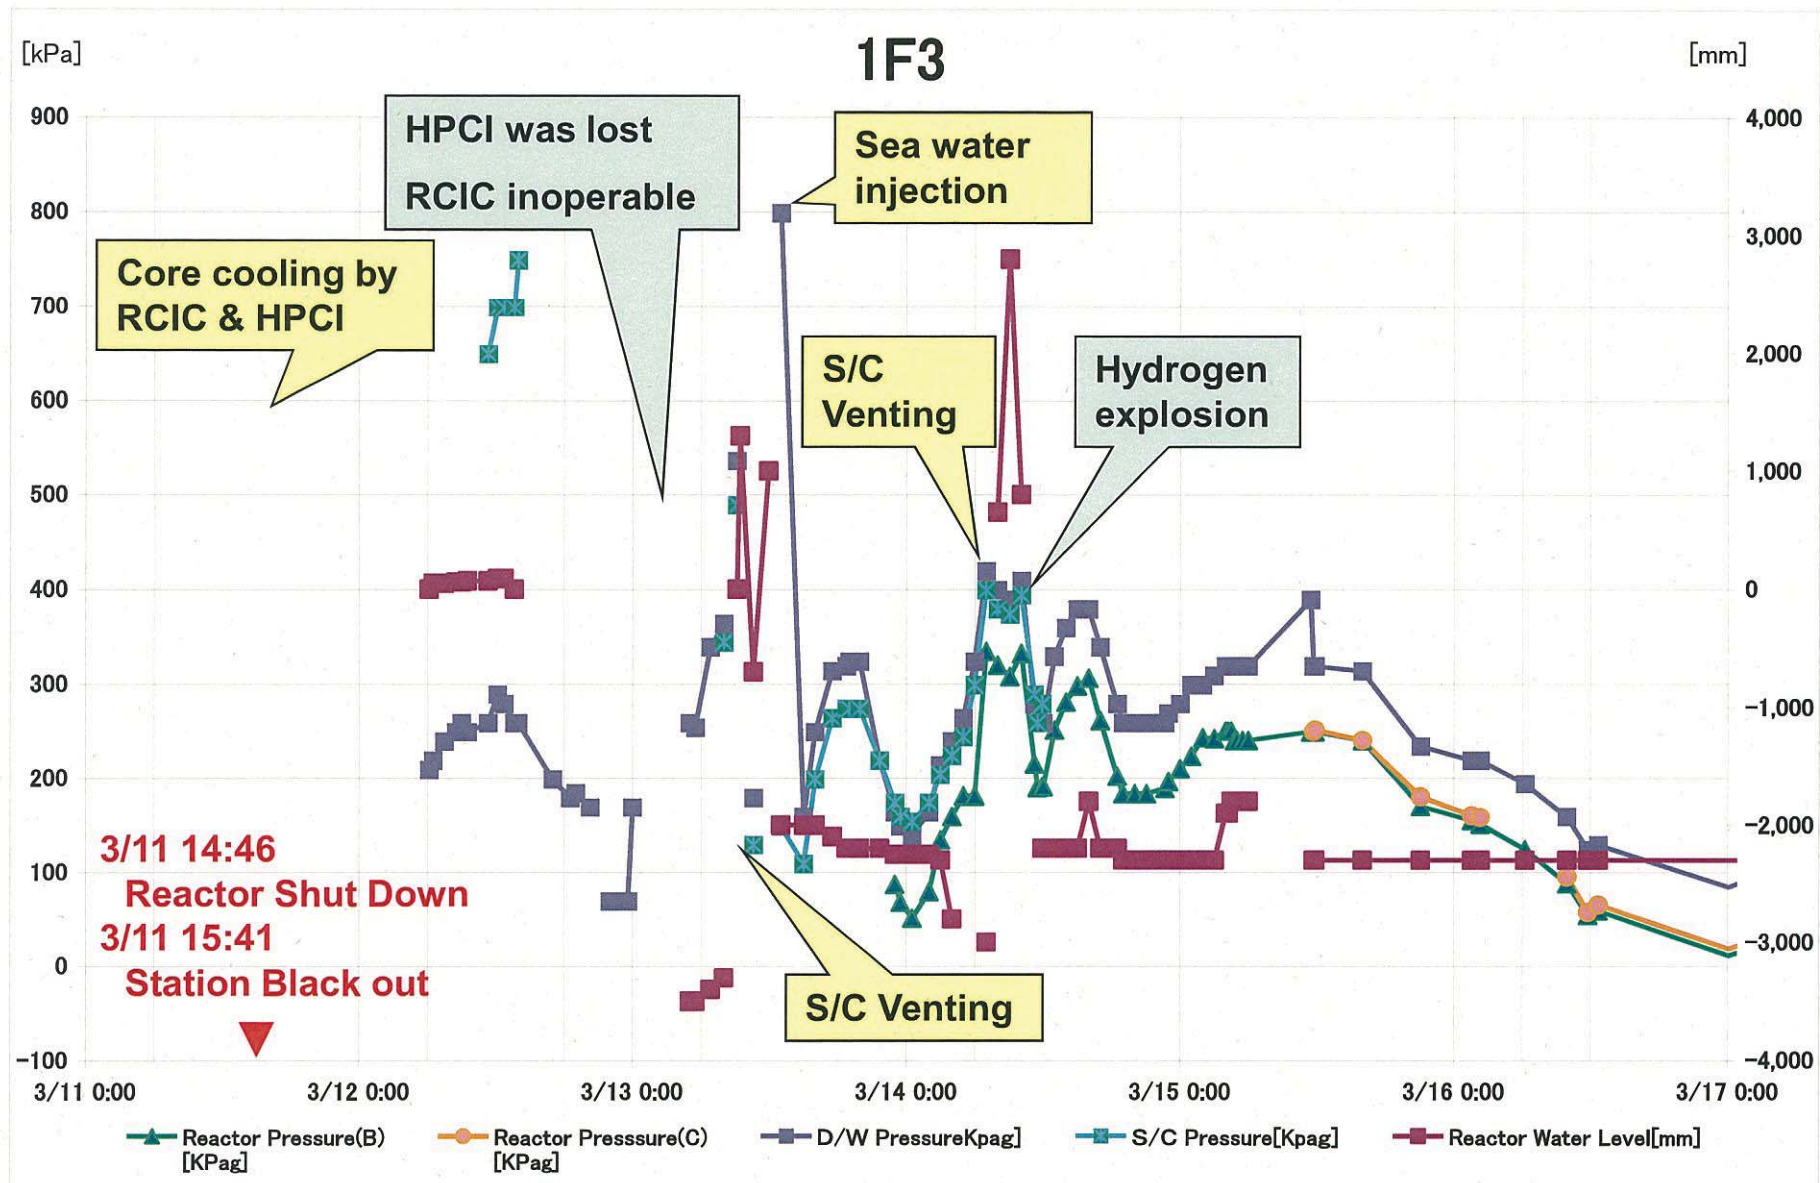
# Trend data of Unit 3 until March 17

- 11<sup>th</sup> ● Under operation, Automatic shutdown by the earthquake  
● Loss of A/C power
- 13<sup>th</sup> ● Loss of water injection function  
● Started to vent
- 14<sup>th</sup> ● Unusual increase in PCV pressure  
● **Sound of explosion (11:01)**
- 16<sup>th</sup> ● White smoke generated
- 17<sup>th</sup> ● Water discharge by the helicopters of Self-Defense Force(4 times)  
● Water spray from the ground by High pressure water-cannon trucks  
(Police: once, Self-Defense Force: 5 times)
- 18<sup>th</sup> ● Water spray from the ground by same trucks (Self-Defense Force: 6 times)  
Water spray from the ground by US water-cannon trucks  
(US armed force:1 time)
- 19<sup>th</sup> ● Water spray from the ground by High pressure water-cannon trucks by  
Hyper Rescue Unit of Tokyo Fire Department.

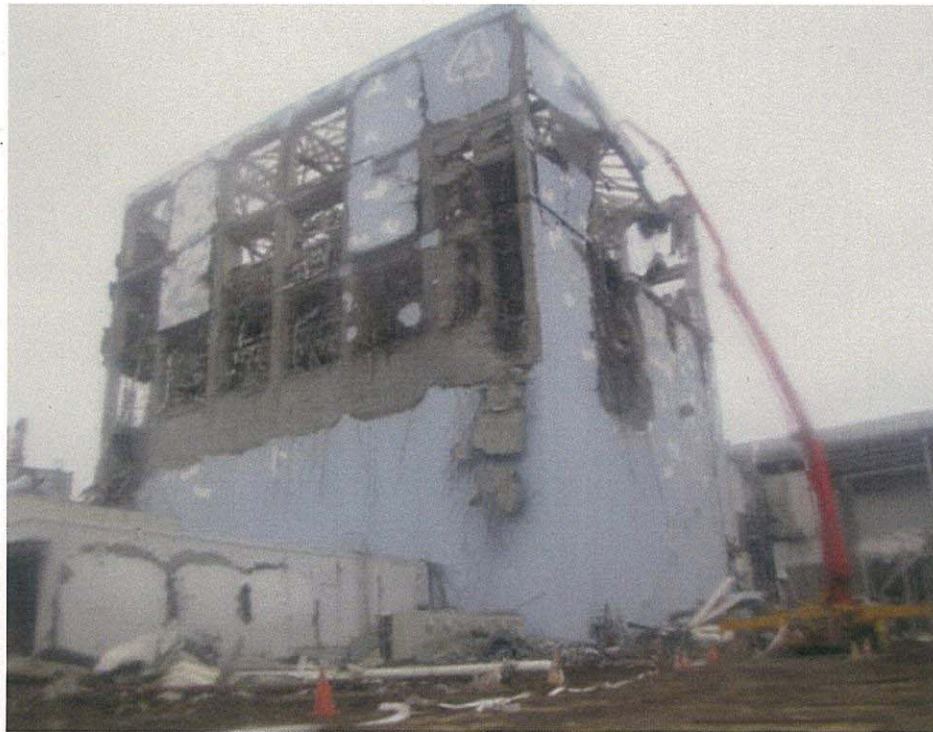
**Photo: Water spray into the SFP in Unit 4 using concrete pump truck**

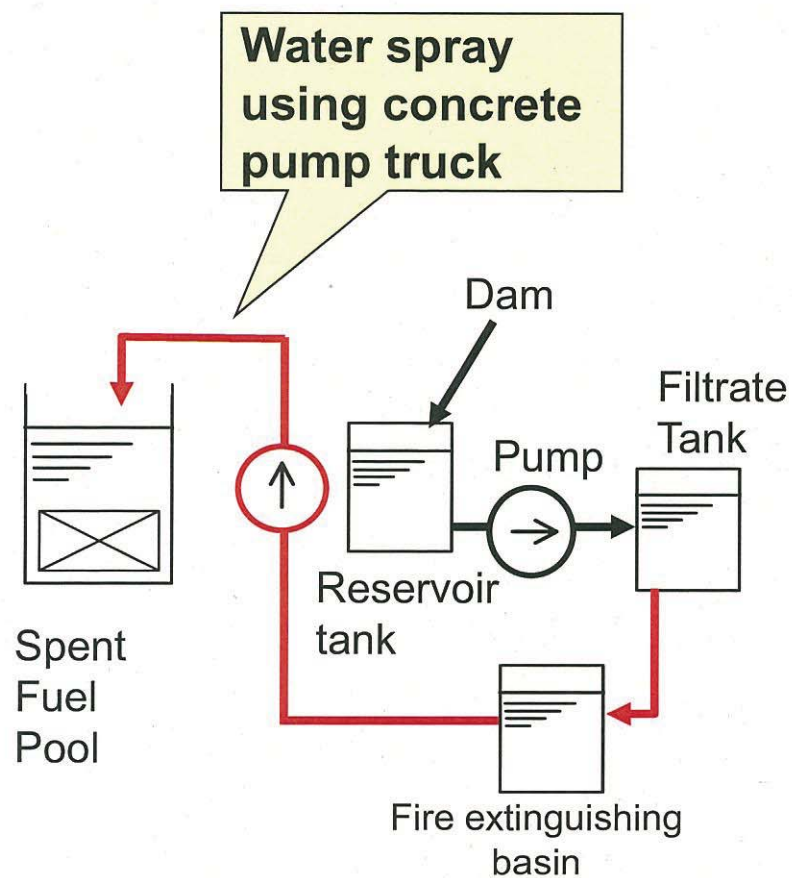
## Unit 1

Fresh water injection

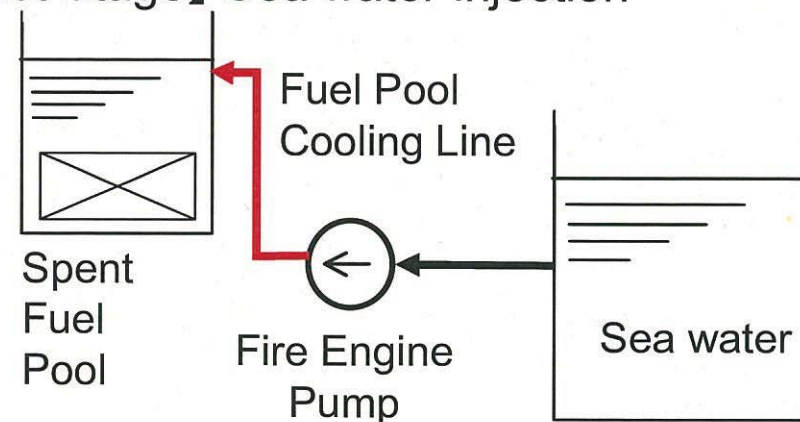
【1st Stage】 Sea water injection

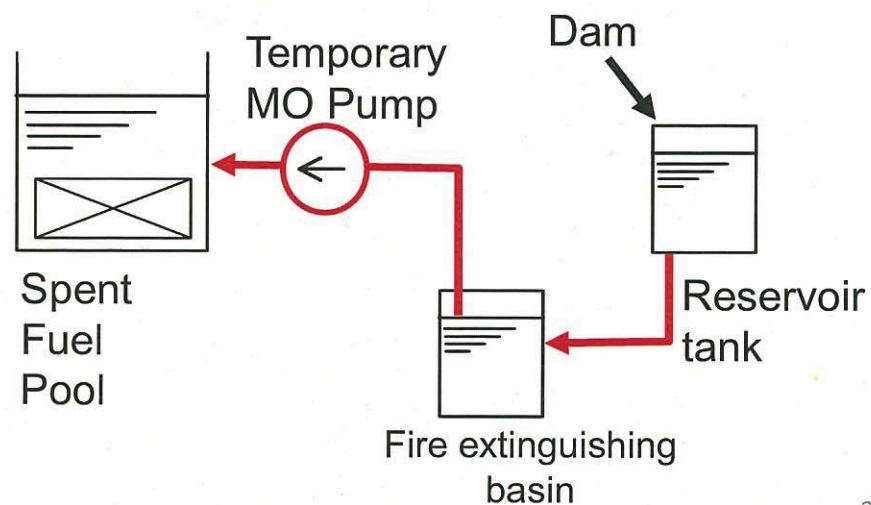
【2nd Stage】 Fresh water injection

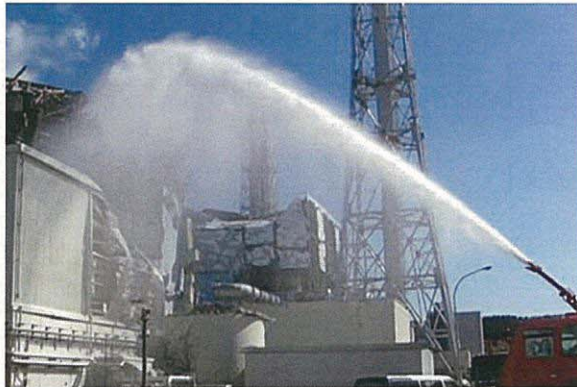
#### Water Spray

by  
-Self-Defense Force  
-Fire Department  
-Police

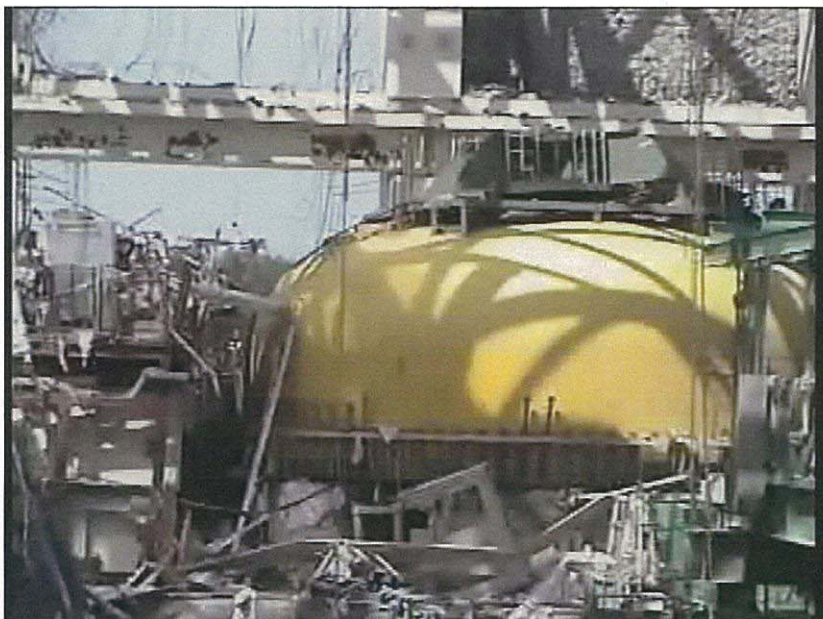
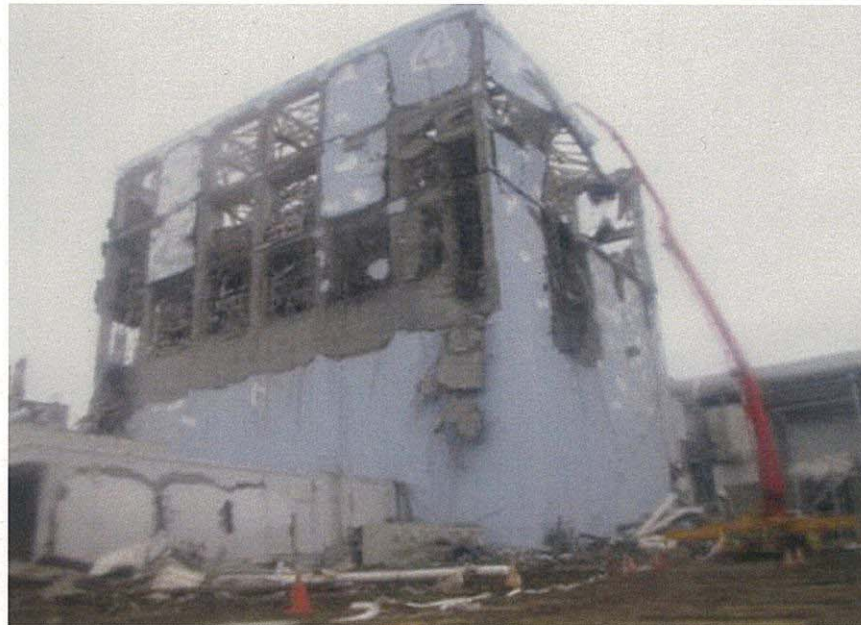
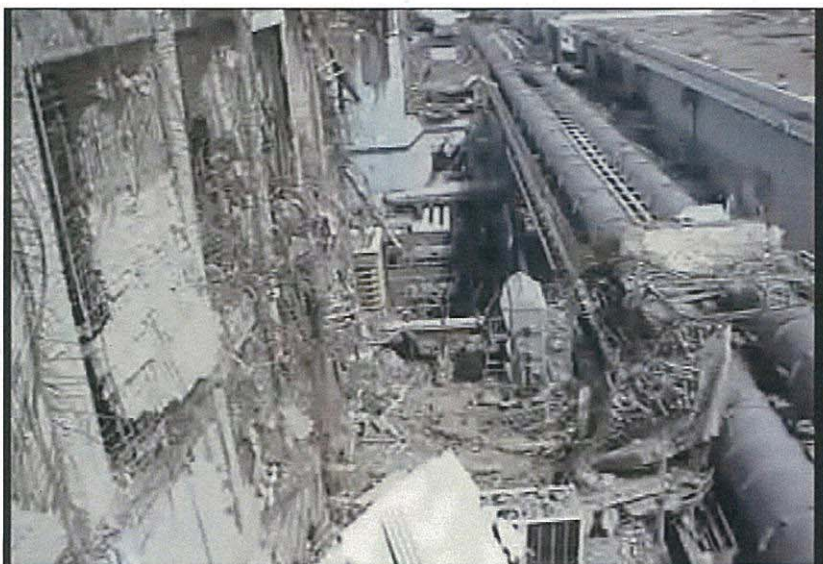
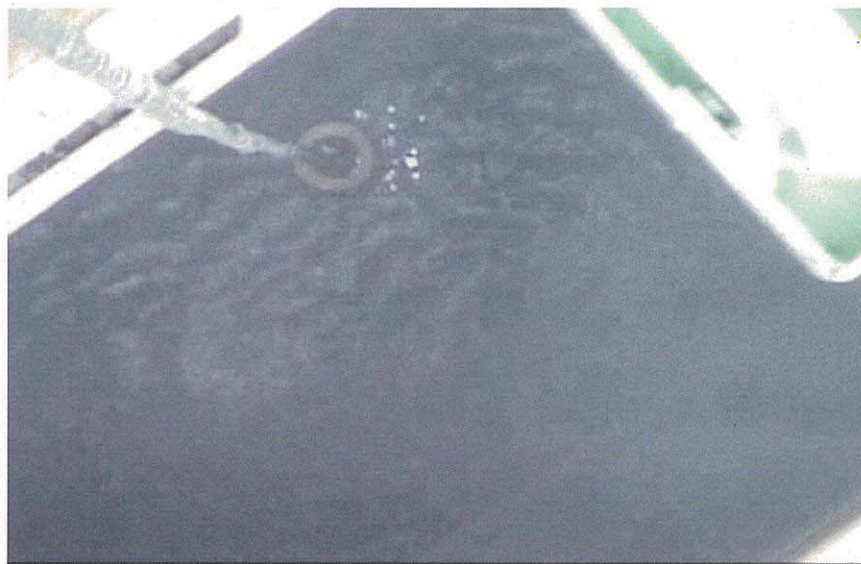
Pictures of Unit 4: <http://www.tepco.co.jp/en/news/110311/index-e.html><sup>37</sup>

- 14<sup>th</sup> ● Water temperature in the Spent Fuel Pool, 84°C
- 15<sup>th</sup> ● Damage of wall in the 4<sup>th</sup> floor confirmed  
● Fire occurred in the 3<sup>rd</sup> floor (12:25 extinguished)
