# **The 3/11 Fukushima Nuclear Accident: What Happened and Lessons learned (so far)**

**“The Nuclear Renaissance and the Risks of Nuclear  
Proliferation in Asia”**

**Tatsujiro Suzuki**

**Vice Chairman, Japan Atomic Energy Commission**

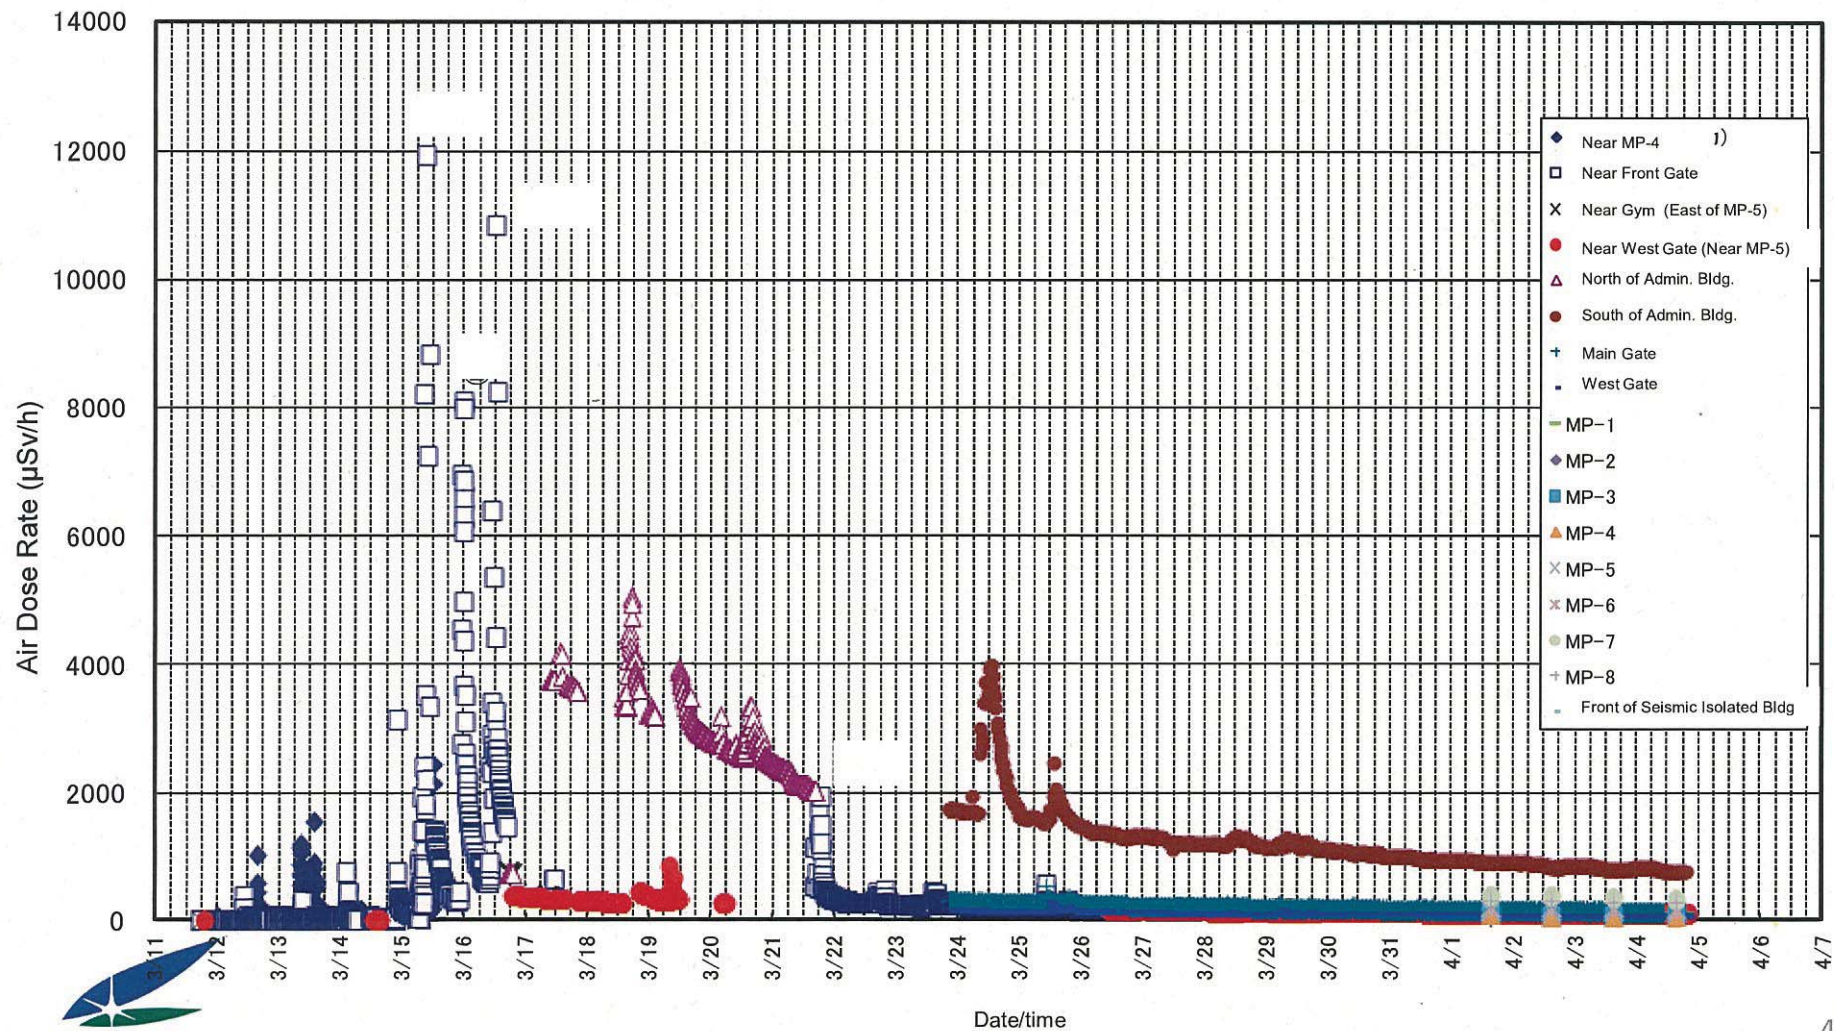
1F Monitoring Trend

○Registered 11930 $\mu$ Sv/h around Front Gate on March 15.

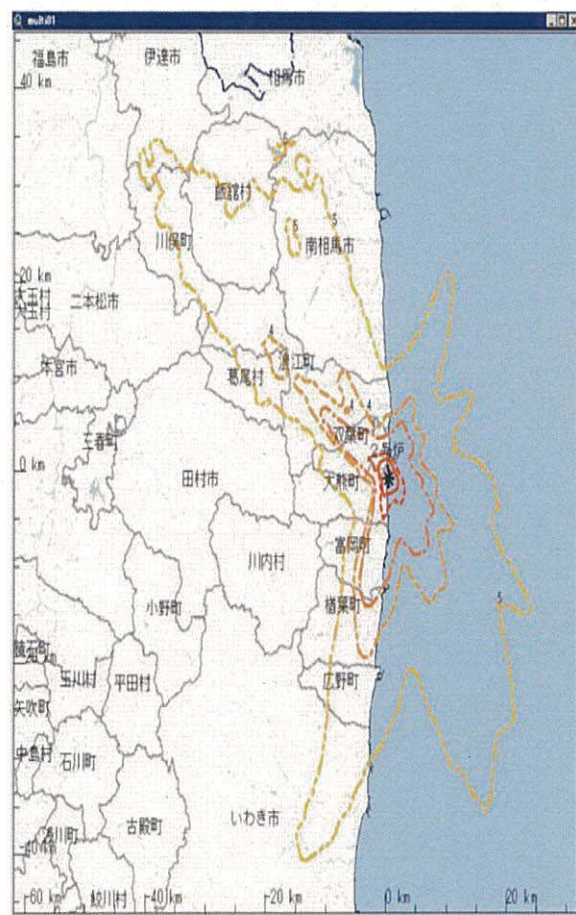
# Estimated Exposure by SPEEDI (2011/03/23, 04/05)

(評価)  
本試算は、福島第一原子力発電所の事故発生後、連続して一日中屋外で過ごすという保守的な条件を仮定して、甲状腺の被ばく線量を試算した

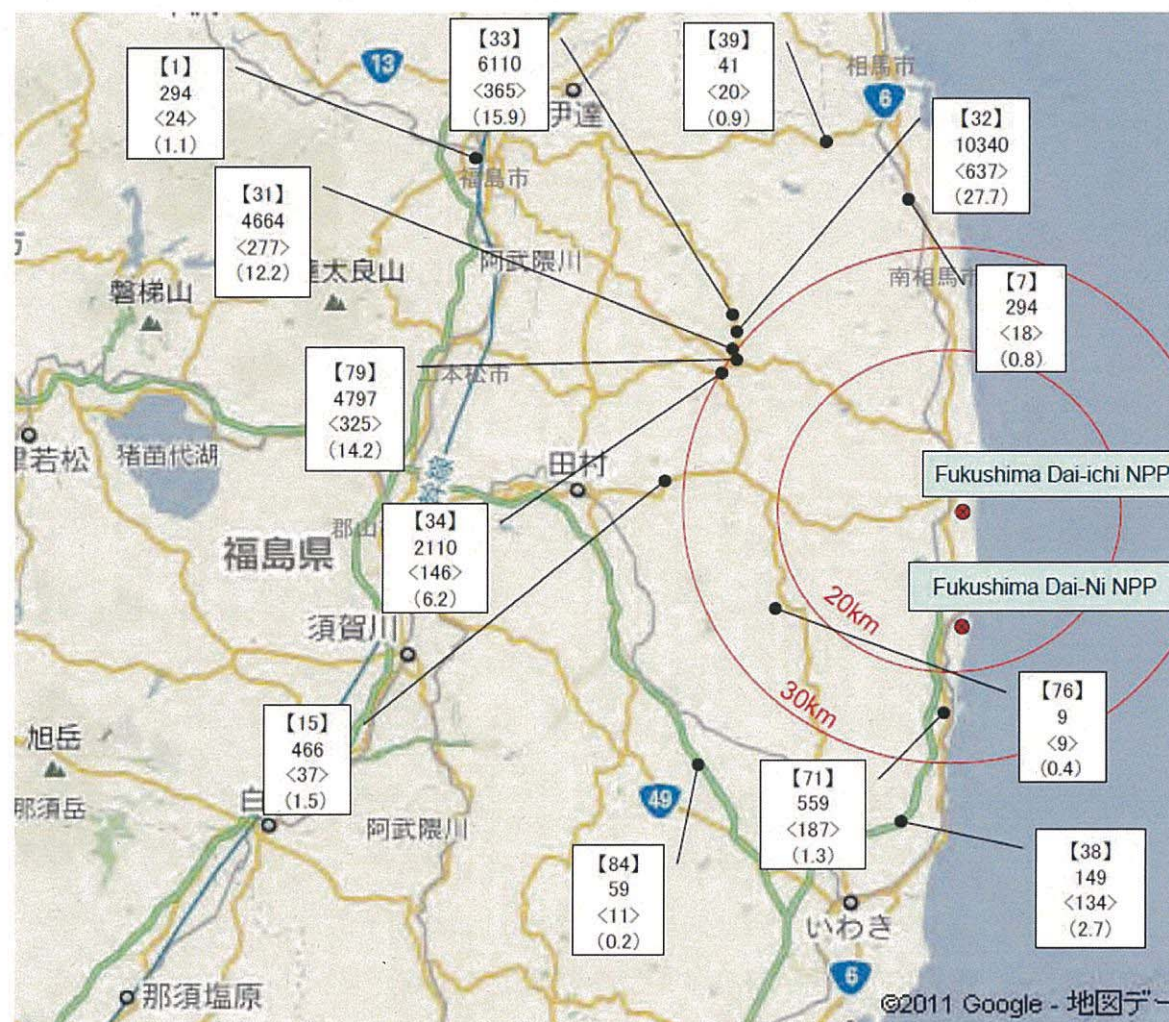
Readings of Integrated Dose at Monitoring Post out of Fukushima Dai-ichi NPP

- Air dose rate cumulatively measured since April 3 topped 10,340 $\mu$ Sv at #32, approximately 30km North West from 1F.

- March 23th ~ April 3rd  
(Monitoring Post: 7, 31 ~ 34, 79)
- March 23 th ~ 28th, April 3rd  
(Monitoring Post: 71)
- March 24 th ~ April 3rd  
(Monitoring Post: 1, 15)
- March 25 th ~ April 1st, April 3rd  
(Monitoring Post: 84)
- March 31 th ~ April 1 st, April 3rd  
(Monitoring Post: 38)
- April 1 th ~ April 3rd  
(Monitoring Post: 39)
- April 2 th ~ April 3rd  
(Monitoring Post: 76)
- Monitoring Post

- Overall dose rate trending down since March 17<sup>th</sup>.
- E.g. The highest value recorded at Monitoring Point #32 has peaked out at approx. 170 $\mu$ Sv/h and has been declining since, rendering no immediate health hazard.
