## 新潟県中越沖地震による柏崎刈羽原子力発電所への影響に関する 国際原子力機関（IAEA）のフォローアップ調査団報告書の公表について

平成20年3月4日  
経済産業省  
原子力安全・保安院

**REPORT**  
**Volume I**  
**ENGINEERING SAFETY REVIEW SERVICES**  
**SEISMIC SAFETY EXPERT MISSION**

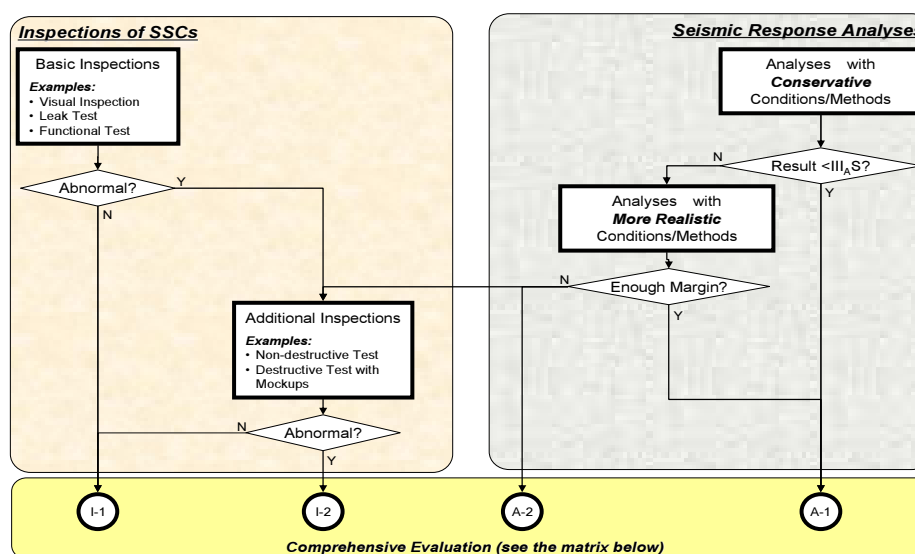
The integrity assessment for systems consists of the following process:

<i>Comprehensive Evaluation Matrix</i>		
Analyses	Inspections	
	No Abnormality (I-1)	Abnormal (I-2)
Enough Margin (A-1)	Judged as Sound	Restoration (Repair/Replacement)
Less Margin (A-2)	Further Analyses and/or Inspections	Restoration (Repair/Replacement)
