英国ソーブ再処理工場の放射性溶液漏えいについて

平成 17 年 6 月 7 日

Thorp Feed Clarification Cell Update

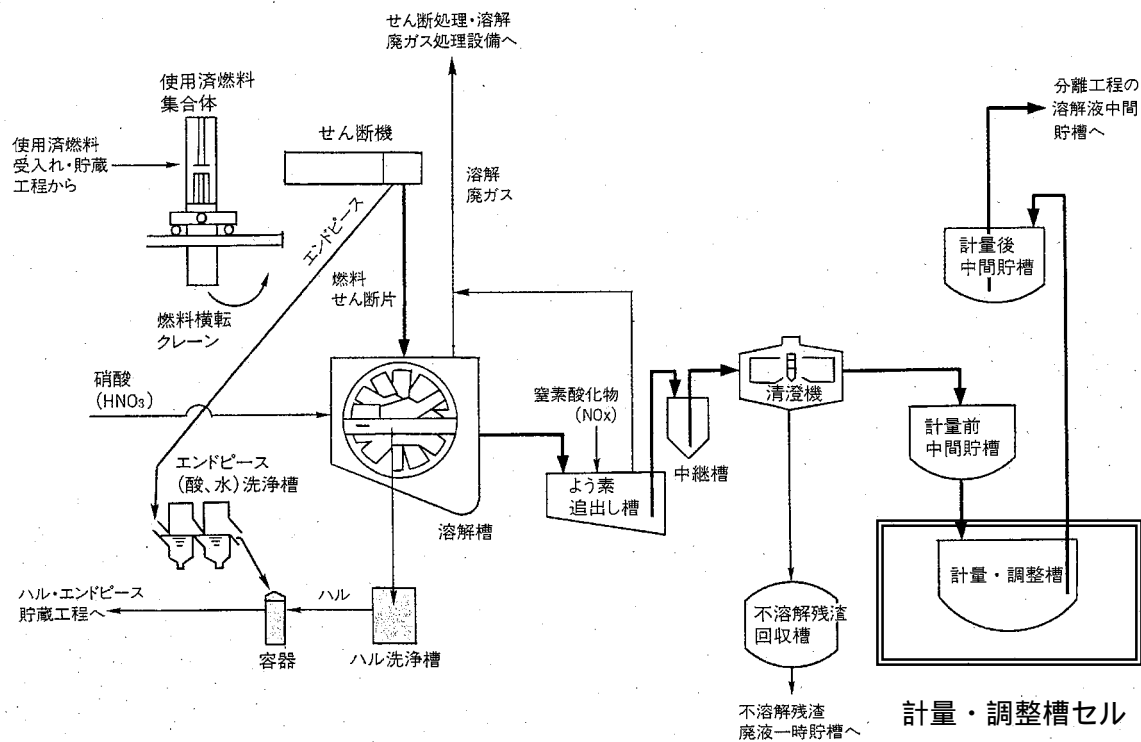
六ヶ所再処理工場 セン断処理施設・溶解施設概要図（計量・調整槽セル）

- (1) 六ヶ所再処理工場では、清澄機で不溶解残渣を除去した後の計量・調整槽に対応すると考える([別紙1 PDF](#)を参照ください)。
- (2) 不溶解残渣を除去した後の溶解液を移送する配管は耐酸性を有するステンレス鋼製であり、また、配管の接続は溶接構造としており、漏えいし難い設計としている。
- (3) 万一、漏えいがあった場合に備えて、例えば、計量・調整槽を収納する計量・調整槽セルにはステンレス鋼製の漏えい液受皿を設けるとともに、漏えい検知装置(二重化)を設置している。また、漏えい液を回収するためにスチームジェットポンプ(二重化)を設置している。なお、この設備で取扱う溶解液の漏えいでは、量によらず臨界のおそれはない。
- (4) セル内の空気は高性能粒子フィルタ等で放射性物質粒子を除去した後、主排気筒から放出する設計としている。
- (5) 六ヶ所再処理工場では、Thorpの計量槽のように吊り下げて重量を測定するタイプの貯槽はない。

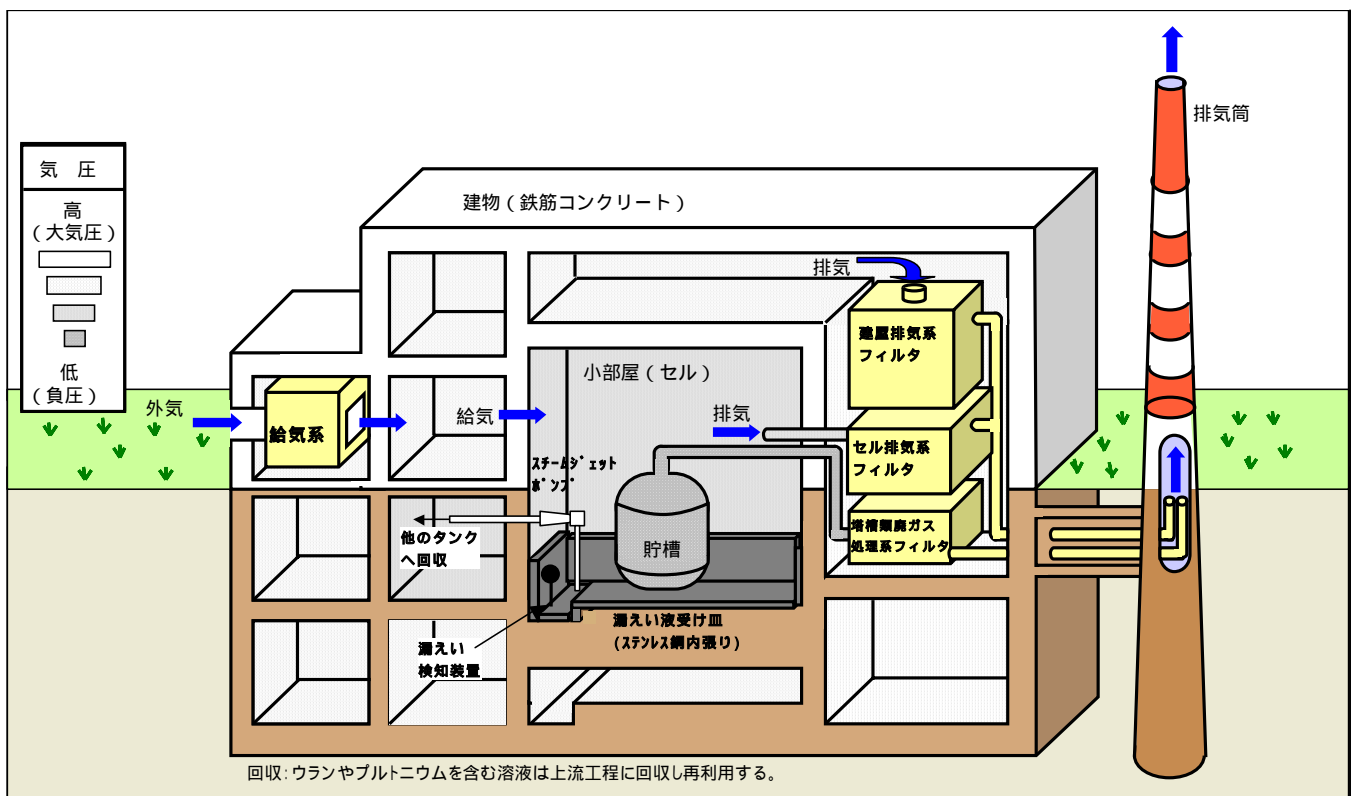
六ヶ所再処理工場における漏えい対策の考え方

1. 六ヶ所再処理工場における漏えい（閉じ込め）対策の考え方

- ・放射性物質を取り扱う機器や配管は、腐食しにくいステンレス鋼やジルコニウムなどの材料を使う。
- ・放射性溶液を取り扱う配管は、原則、継ぎ手（フランジ）構造ではなく溶接構造にするなど漏えいしにくい設計とする。

- ・機器や配管は、床面をステンレス鋼で内張りした厚い頑丈な鉄筋コンクリートの壁に囲まれた小部屋（セル）に設置する。
- ・万一の漏えいに備え、漏えい検知装置、漏えい液回収設備を設置する。

- ・建物内部の気圧を「建物」「小部屋（セル）」「装置」の順に低くし、気体状の放射性物質を建物の内側に閉じ込める。
- ・「建物」「小部屋（セル）」「装置」内の空気は、フィルタを通して主排気筒から放出する。

しかしながら、万一の漏えいに備えて、漏えいし難い構造とするとともに、漏えいが拡大しない設計、周辺環境への影響を低減する設計としている(六ヶ所再処理工場における漏えい対策の考え方を[別紙2 PDF](#)に示す)。

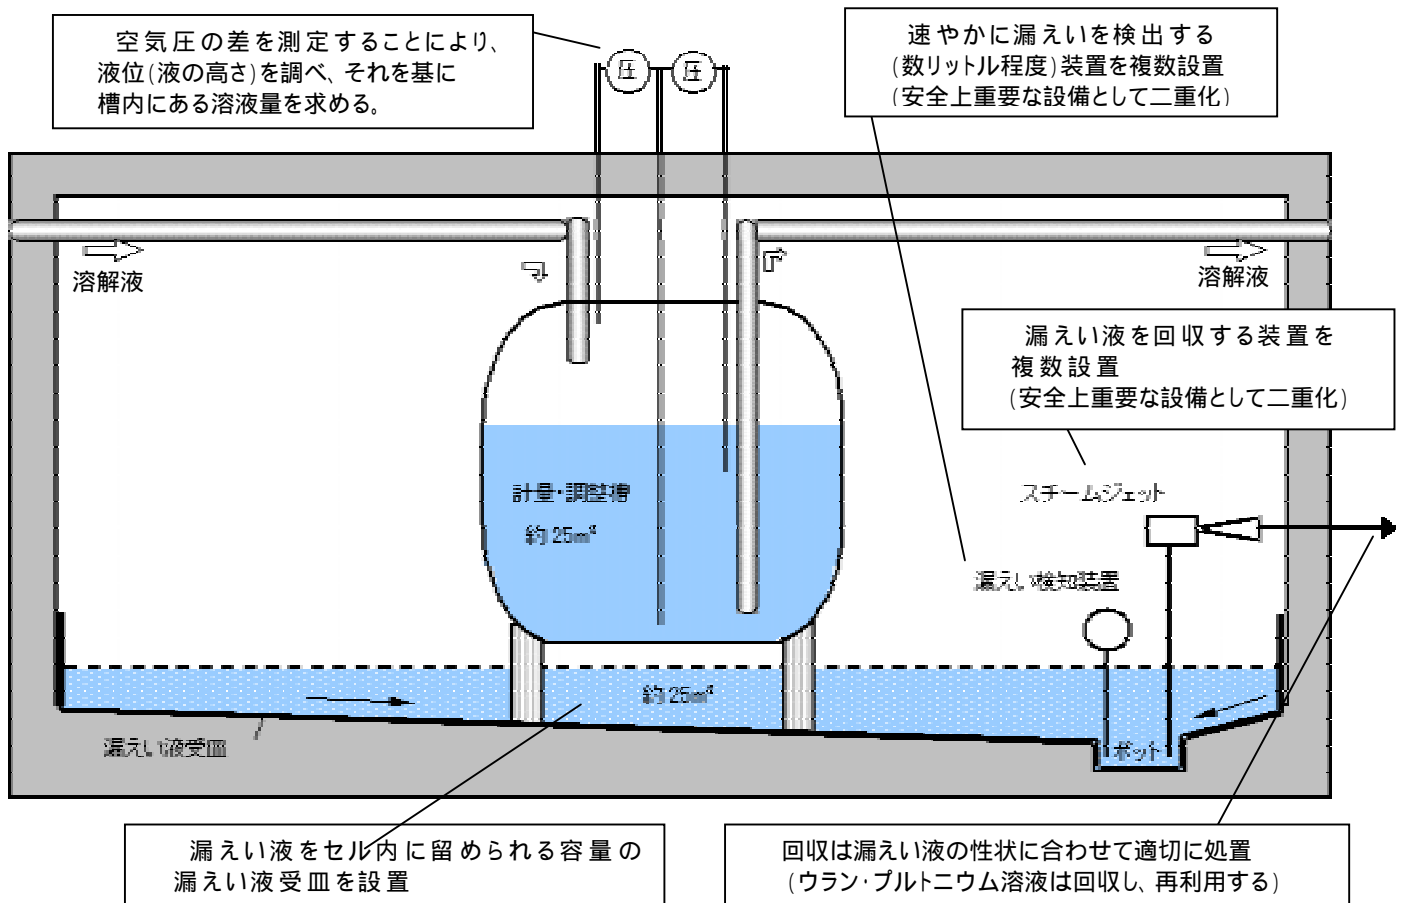
2. 計量・調整槽セルの漏えい（閉じ込め）対策

- (1) ソープの計量槽に対応すると考えられる計量・調整槽は、仏国 COGEMA 社より技術導入した設備であり、ソープの計量槽のように吊り下げタイプではなく、据置きタイプの貯槽である。
- (2) 不溶解残渣を除去した後の溶解液を移送する配管は、耐酸性を有するステンレス鋼製である。また、配管の接続は溶接構造としており、漏えいし難い設計としている。
- (3) 計量・調整槽を収納する計量・調整槽セルは万一の漏えいに備えて以下の設計としている。
- ステンレス鋼製の漏えい液受皿を設置している。
 - 速やかに漏えいを検出する漏えい検知装置を設置（二重化）している。
 - 漏えい液を回収するためにスチームジェットポンプを設置（二重化）している。
- (4) 本設備で取扱う溶解液の濃度では、量によらず臨界のおそれはない。

注1) 図は計量・調整槽セル内にある最大容量の計量・調整槽のみを記載し、他のこれより小さい貯槽は省略。
